HOUSE PRE-PURCHASE INSPECTIONS

House Inspection At

Demo street

Inspection type Pre-purchase & Methamphetamine spot test

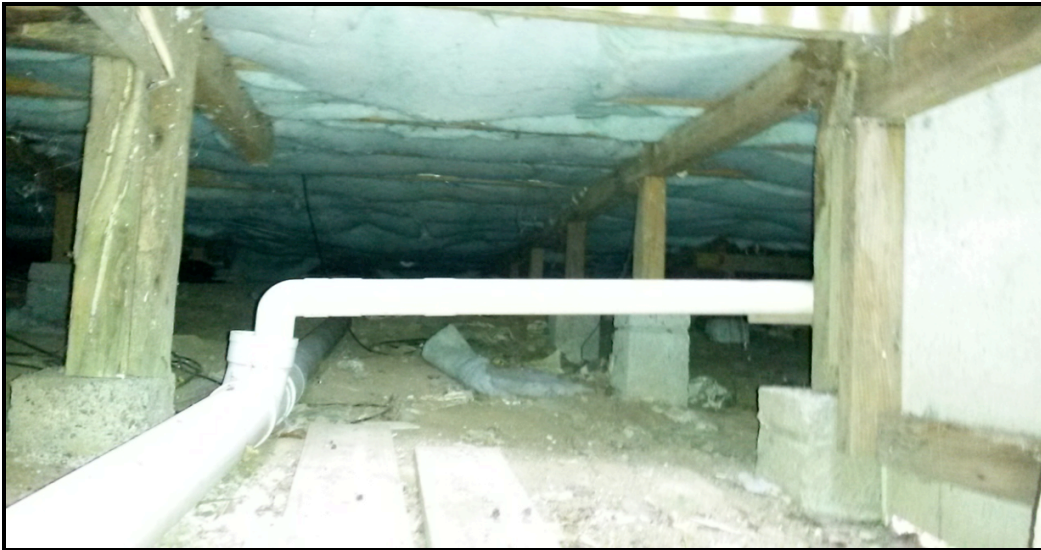
- Timber pile on foundation block.
- The subfloor looks to be in good condition with minor settling of piles due to natural movement of the soil.

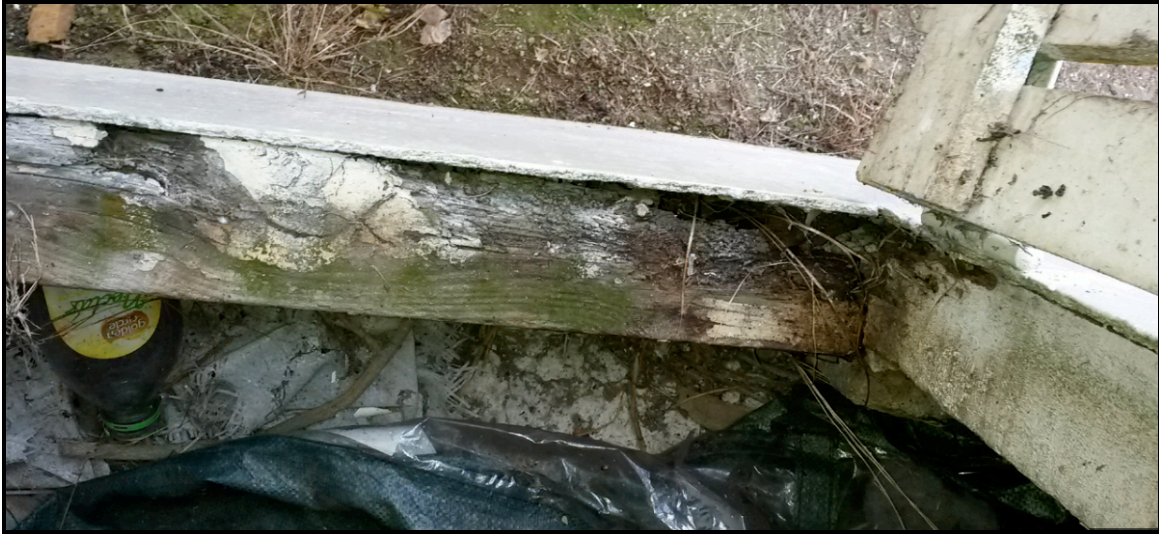
- I have noted some rot to the base cladding framework which is non-structural.

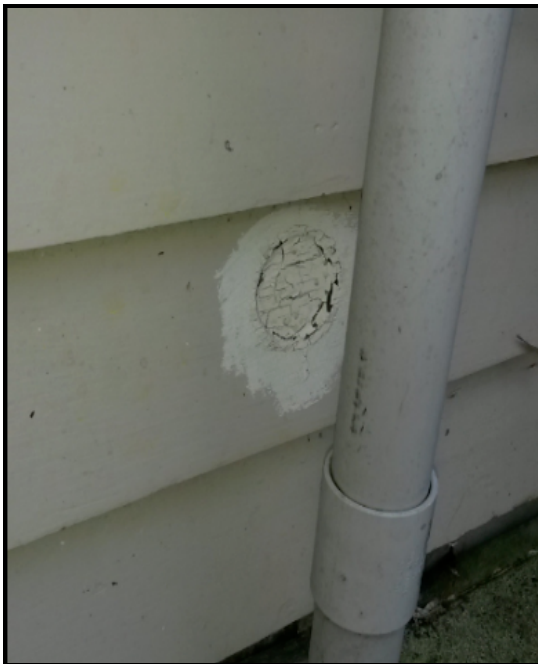
Outside of bathroom/laundry old repair

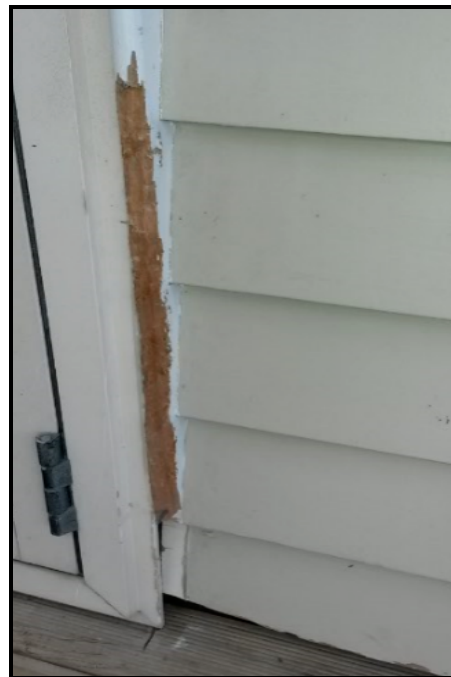
Dog damage to scribber and weatherboard On rear deck

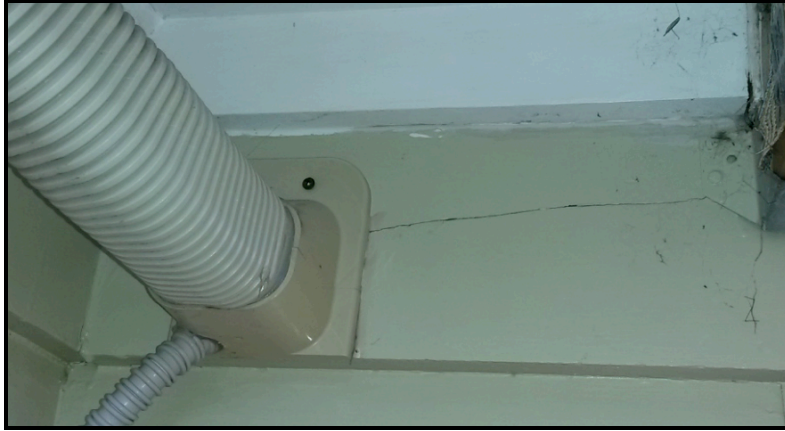
- Crack to weatherboard where air conditioning unit is installed.(protected by eve)

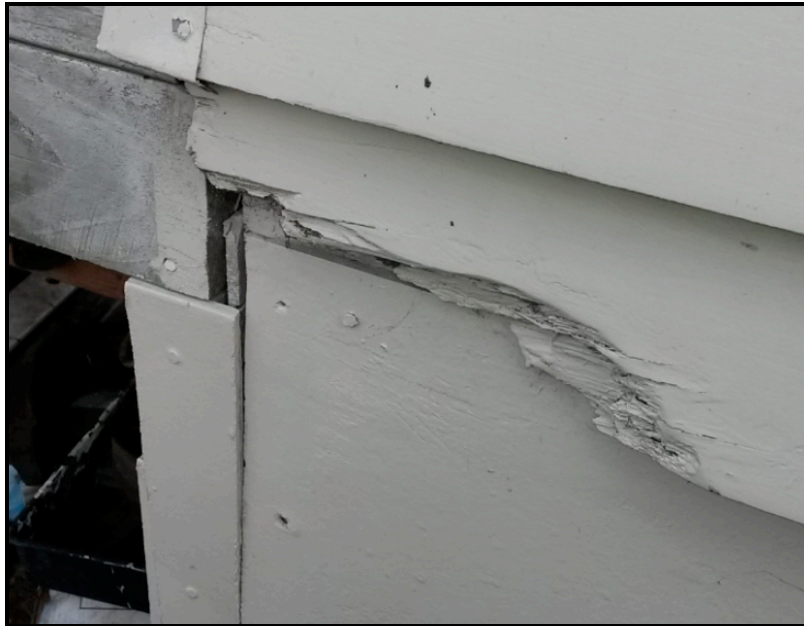
- Old damage to the bottom weather-board eastern elevation/rear of home.
- This damage is below the internal floor level but should be repaired in any case.

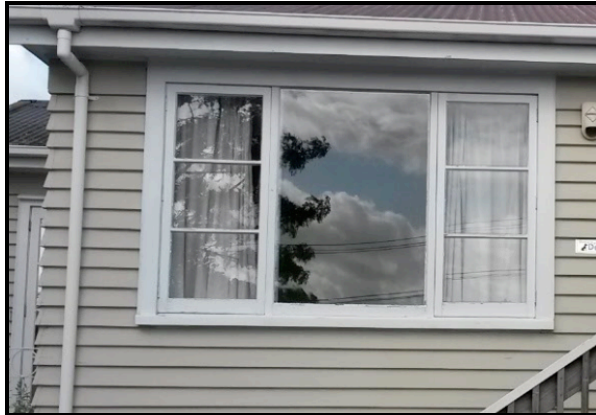
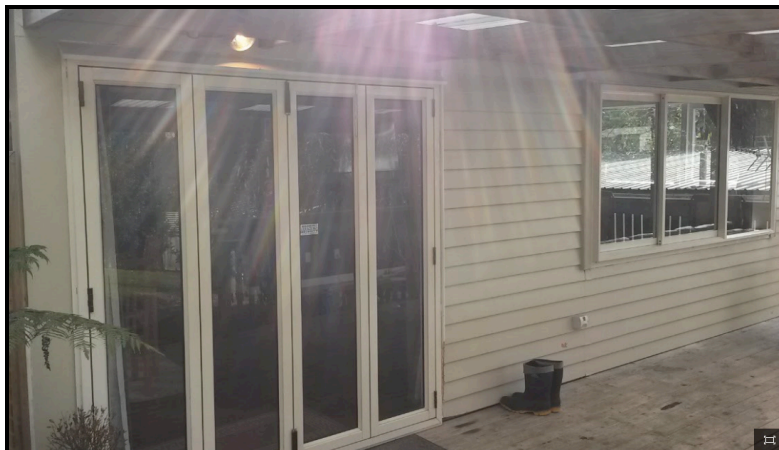
I have found the aluminum joinery to be in good condition but the timber joinery is showing signs of gradual damage/wear and tear with areas of rot.

- The timber joinery will require the paint to be striped/sanded rot removed and filled or replaced with new timber and re painted.
- I have only noted minimal areas of internal moisture around these windows which is expected with timber in this condition.

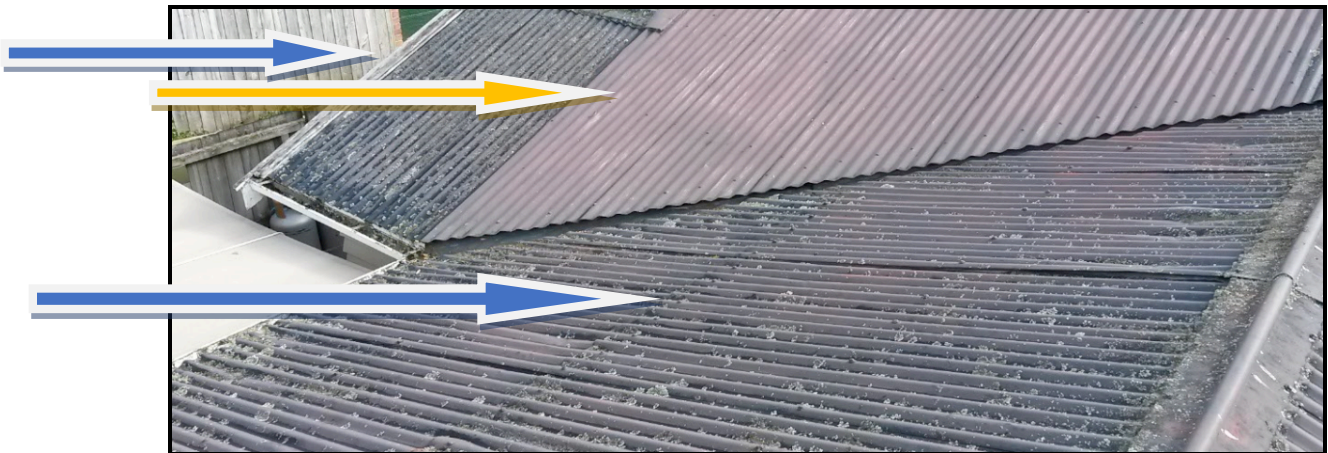
Orange arrow-Newer roof area, Blue arrow-Old area of roof

- The old iron roof area is fitted with led nails and these are loose
- I have noted small areas of moisture on the ceiling inside the home probably due to small drips from around loose nails or where nails have lost their heads.
- The iron is also covered in thick moss/lichen, and has areas of minor to full thickness rust.

- *Contact local authority and uplift L.I.M. report.*
- *Also check council records to ensure all work has been approved.*
- *Plumber to check and repair issues in wet areas*
- *Roof to be temporarily repaired until full replacement can be done (replace nails with tech screws, lichen treat, patch areas of rust)*

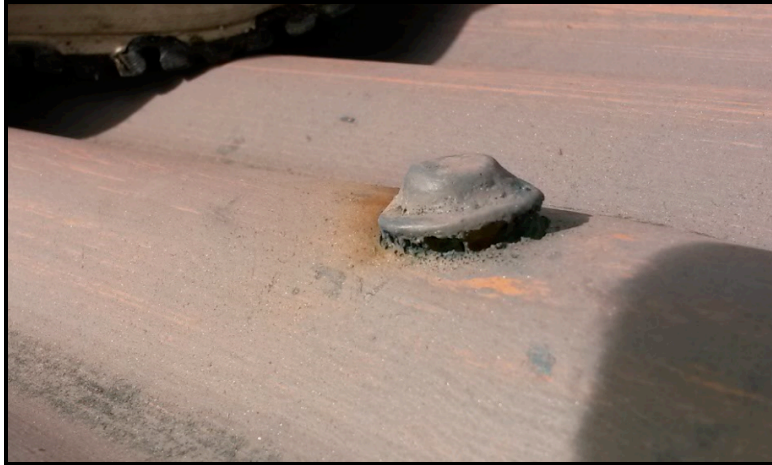
Lead nail loose- recommend these area replaced with screws

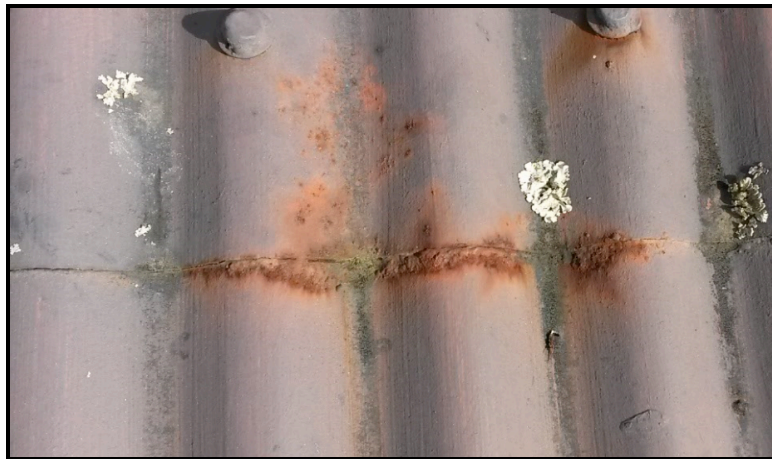
Minor rust at join in iron

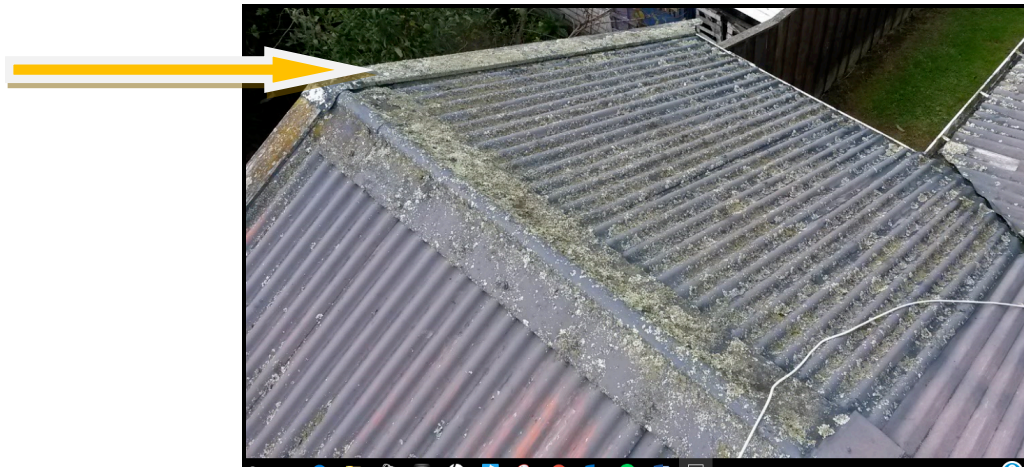
Heavy Lichen on roof, also timber barge requires replacement-Orange arrow

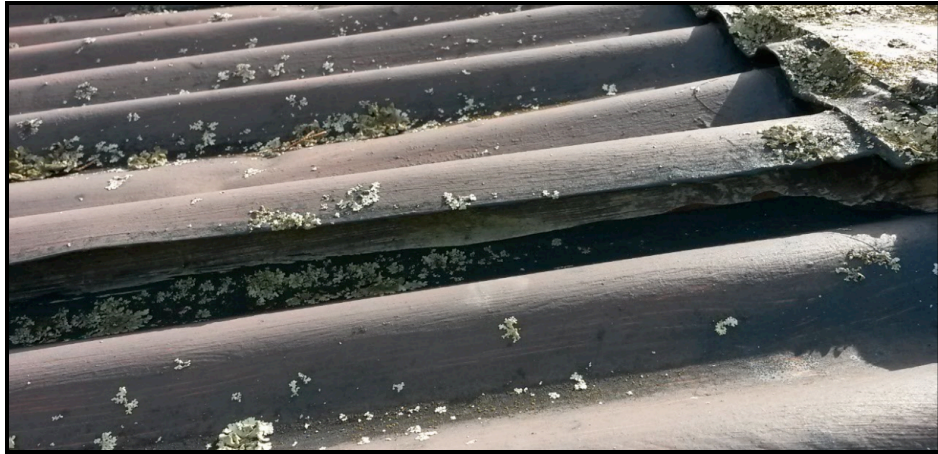
Iron lifting at joins in several areas

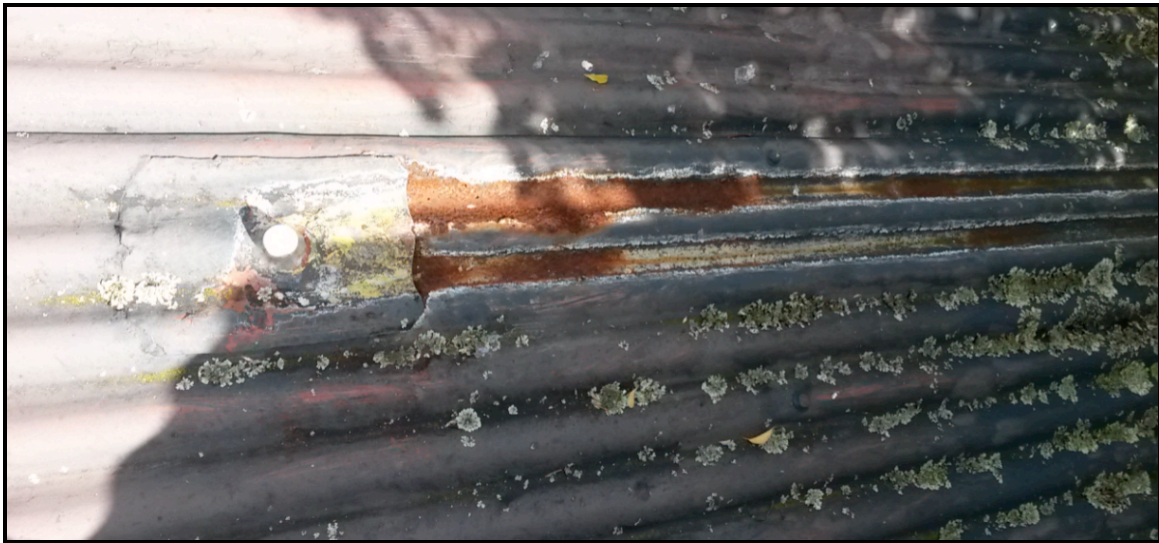
- This area is where the old hot water cylinder overflow was positioned. Due to the constant run of moisture when there was a H/W/C, the iron has full thickness rust. Under the led flashing the rust is very bad.

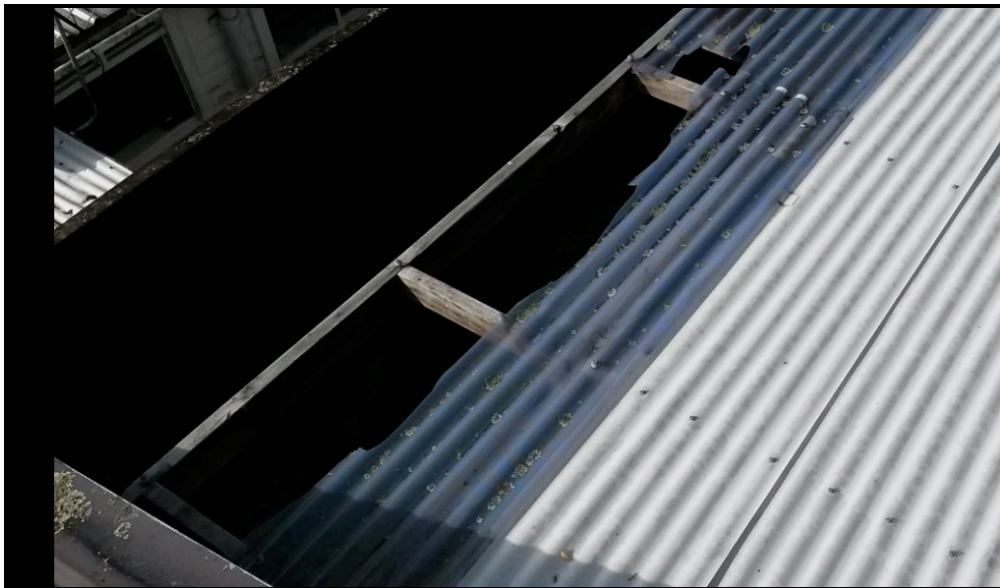
- Rear main deck from lounge is in good condition. I have not found any concerns.
- The roof over the deck is well over 10 sqm and these type of areas do require consent. Check L.I.M.
- Note the last sheet of the corrugated plastic roof is damaged. The span of the roofing is to large and wind will vibrate the roofing and eventually cause breakage. (this requires roofing to be removed and new purlins to be fitted on top at the required spacing's to suit the material.)

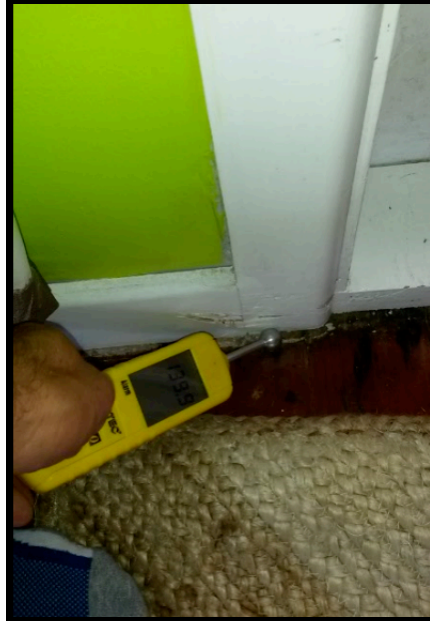
I have detected moderate to high moisture on the south western side of the lounge along the floor. I was unable to locate a cause of this.

This area of moisture is very high and needs investigation as to its cause

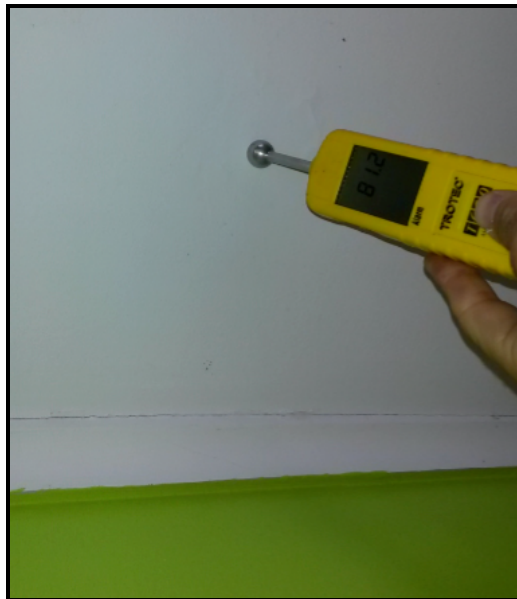
Small spot check has found small area of moisture on lounge ceiling. Probably due to loose nails or rust on roof as advised earlier.

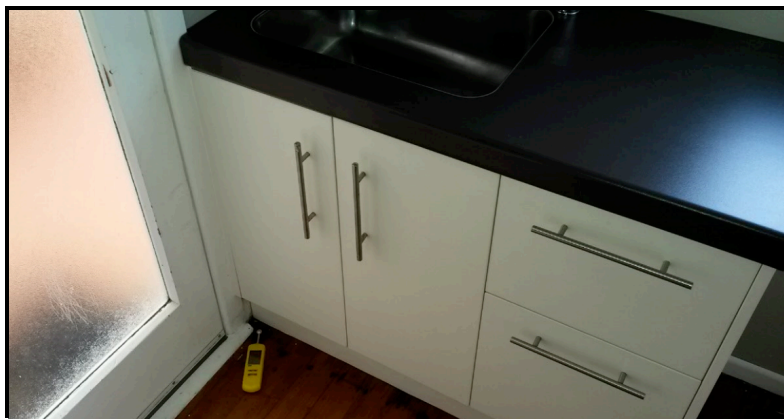
Small bench with sink- high moisture around base

This requires a plumber to inspect and locate the cause of each.

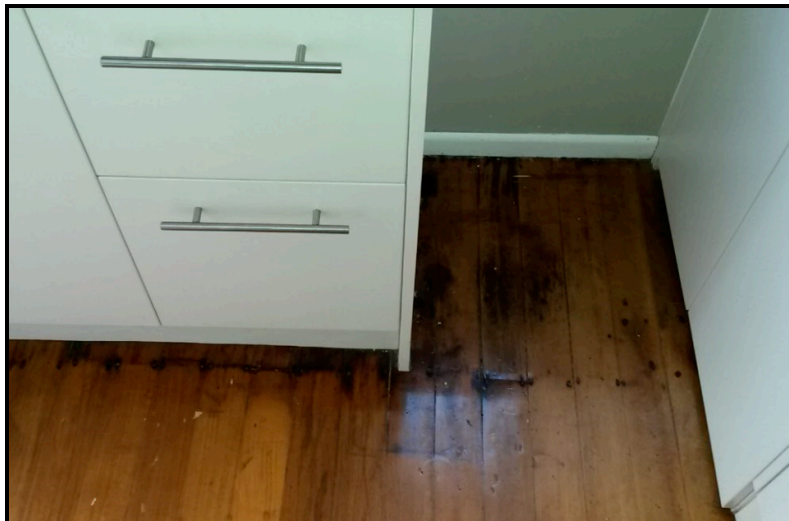
Dark stain around small bench with sink- possible pipe leak.

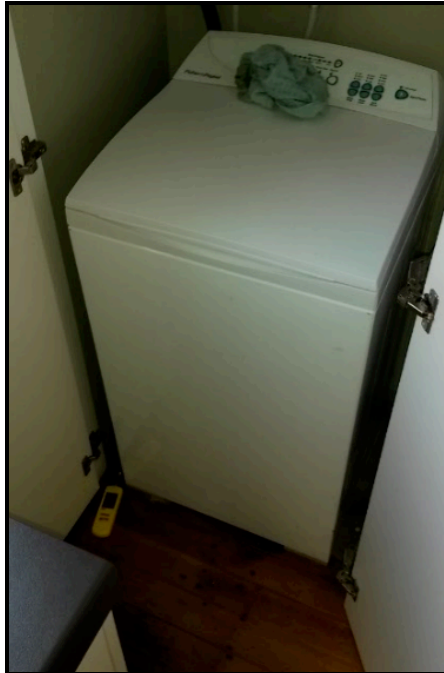
High moisture around washing machine –possibly just a loose conection.

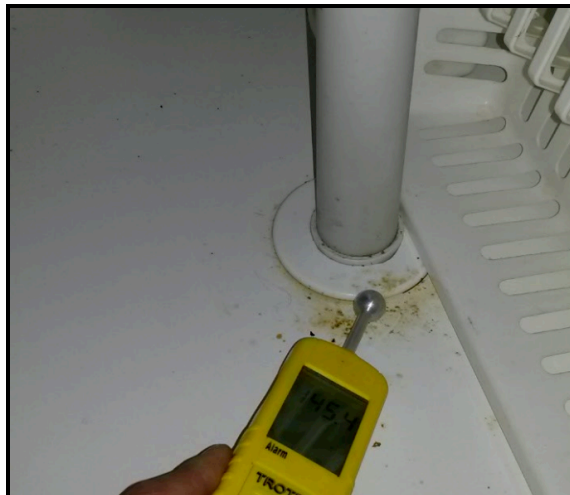
High moisture under main sink- looks to be from loose waste pipe below

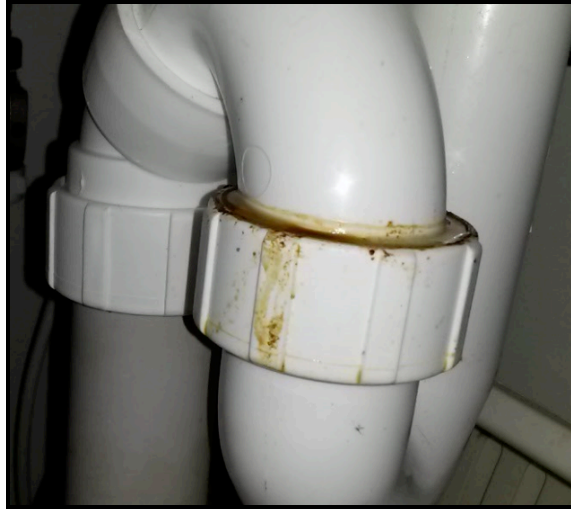
Leaking waste pipe- needs tightening or new rubber seal.

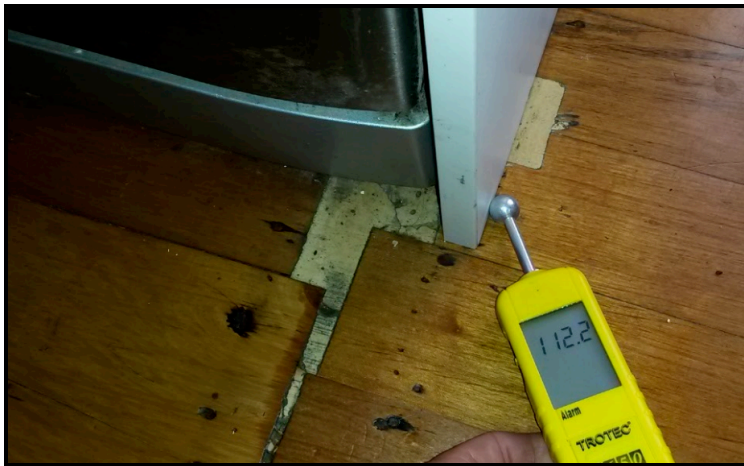
High moisture around dishwasher- possible loose connection.

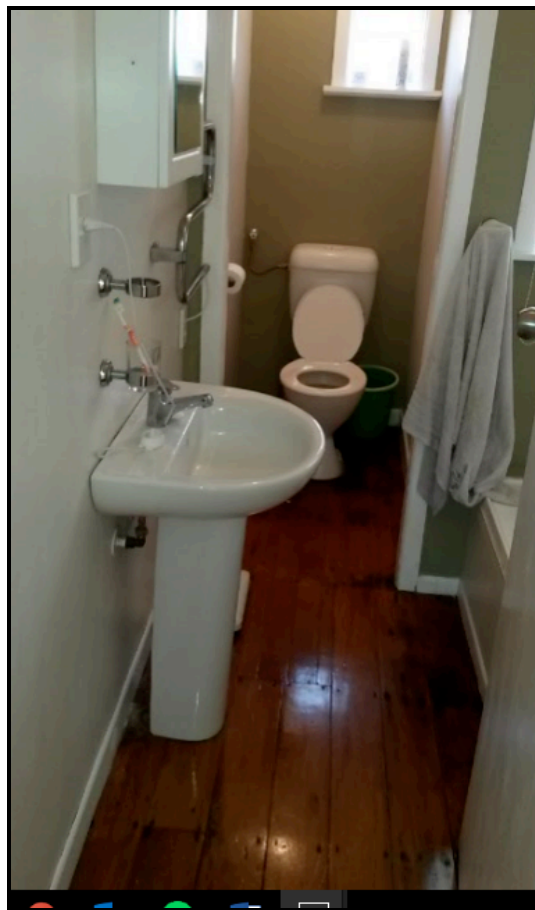
I have found the bath in the bathroom is suffering from a failure of the water seal around the edge, this is due to bad design of the bath cradle etc. (this is very common for baths more than 10 years old. Moisture has been detected at 500mm high in bedroom three behind bath taps.

Visible dark staining on floor from moisture.

- The bath needs to be removed and I would advise replacing with a newer bath designed for a shower over bath scenario (these baths have high lips around the edge to prevent water from entering the wall)

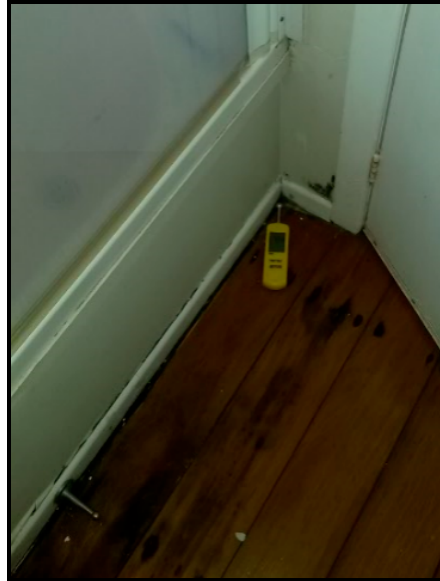
Dark stain and high moisture by bath

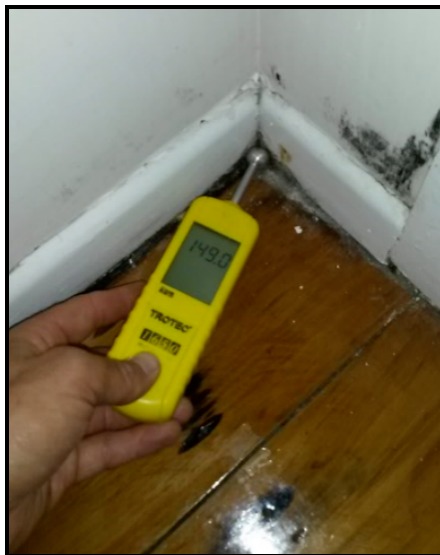
High moisture under bath

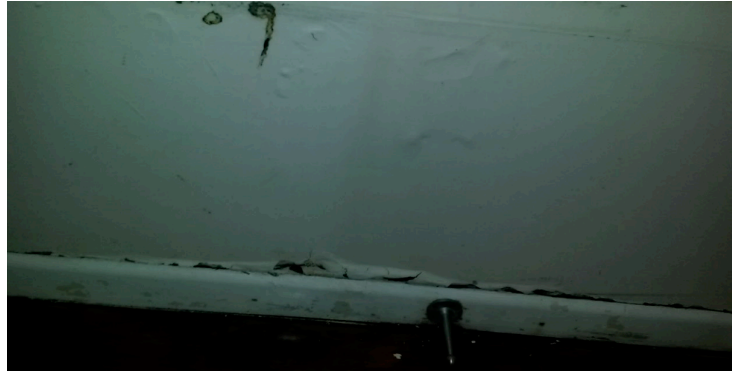
Visible damage to bath cradle.

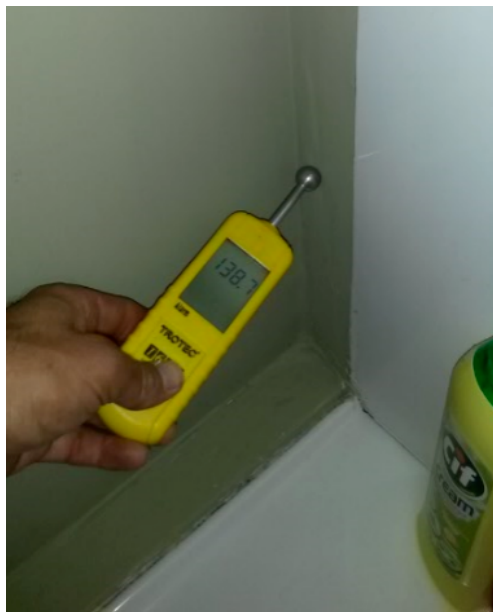
High moisture to bath surround

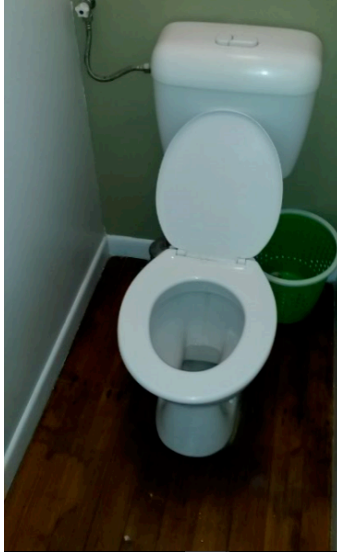
I have also found there is an issue with moisture around the toilet. This moisture is around the base but also up the wall behind pointing towards a pipe leak in the wall or around the cistern pipe.

Dark stains around toilet, high moisture readings (plumber to check)

- A plumber needs to investigate and re fit the toilet. The dark stain will be permanent but the timber is solid.

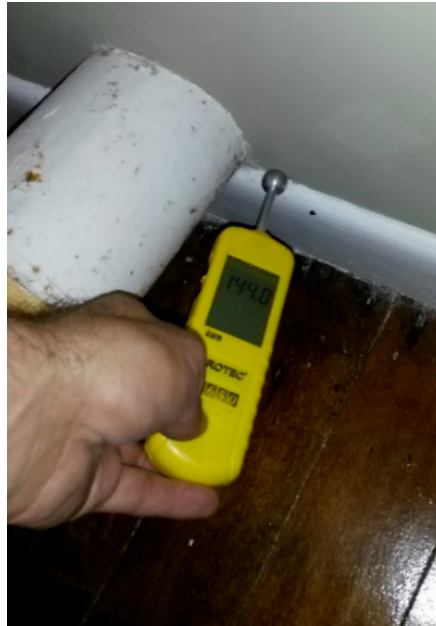
High moisture on wall behind toilet shows pipe leak

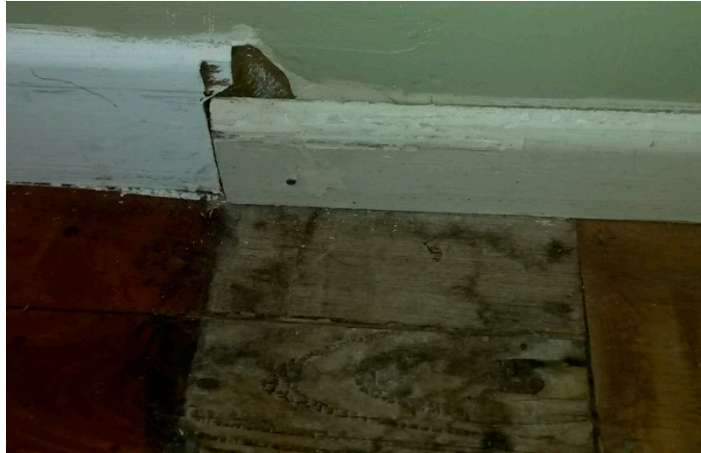
There is visible aesthetic finishing work required in here.

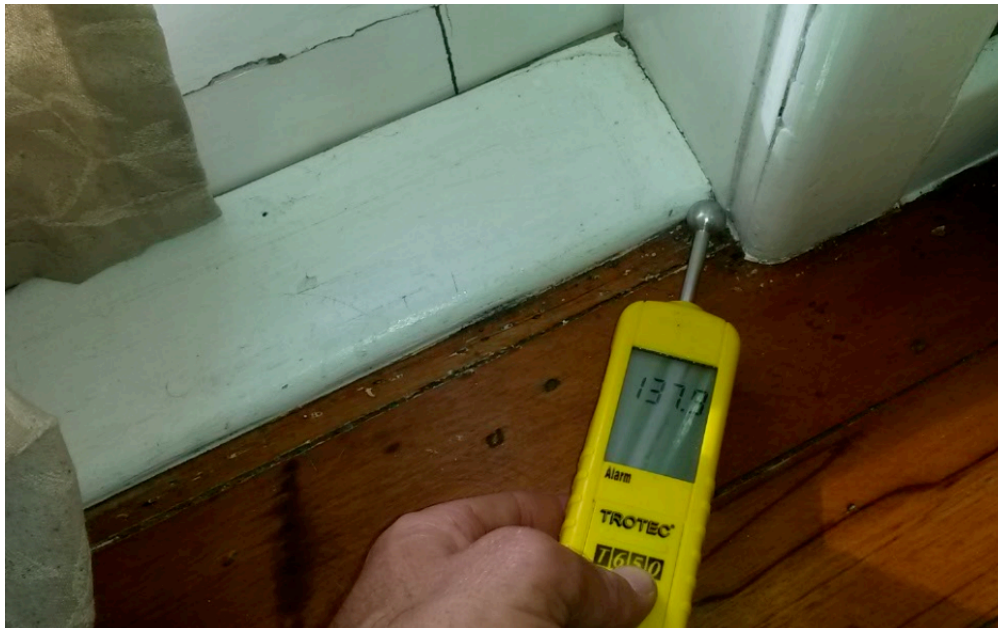
I have noted moderate moisture around the external walls at floor level as advised in most areas, this moisture rises to high around the external timber door to the small deck. Again I feel this is just due to moisture transfer but may require the door to be removed and a flashing fitted in the future to prevent rot from taking hold.

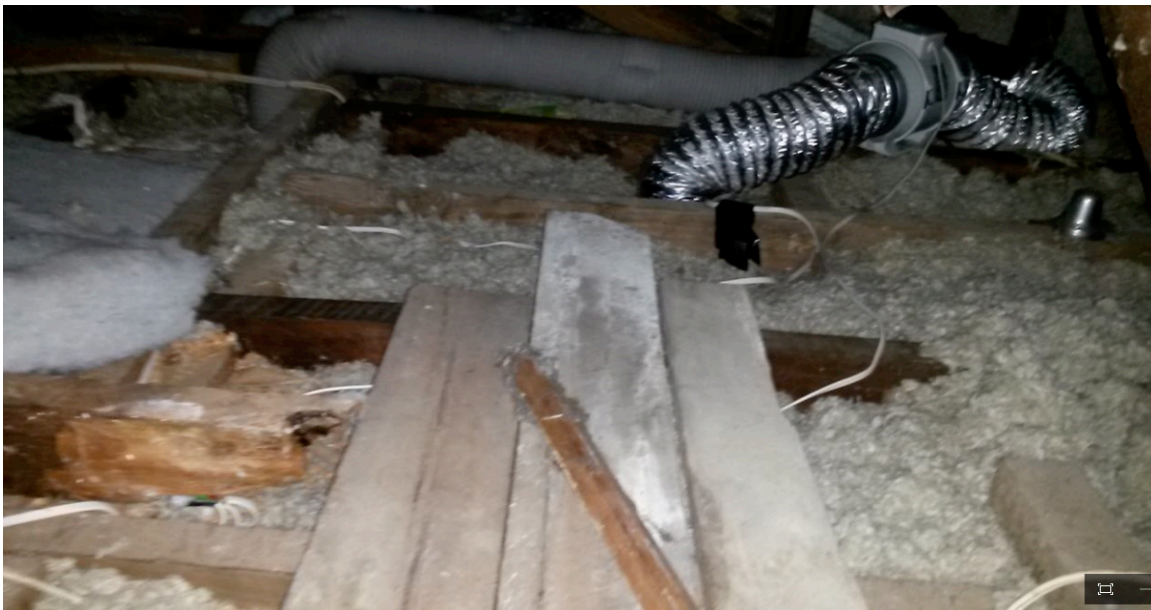
Newer roof area has roofing paper fitted but old area does not. Timber looks to be in good condition with no visible rot. Roof insulation is present
